**Flood Control Project Maintenance
Levee Inspections**

Maintenance Issue Types Only, Levee Inspection Report By Mile - Fall 2015

Reclamation District No. 0544 Upper Roberts Island

Waterway	Bank	Unit Miles	Inspection Start/End	Inspector
Unit No. 01 San Joaquin River	Left	6.05	10/22/2015 10/22/2015	Richard Willoughby

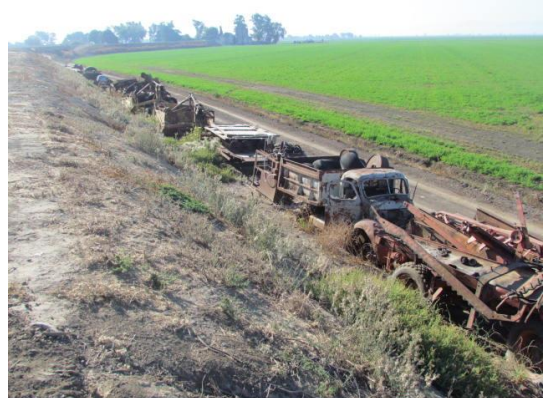
Photo 2 of 5 : FA_2015_RD0544_108_4_20151023_00092.jpg

Looking southwest at equipment stored at landward toe fall 2015.

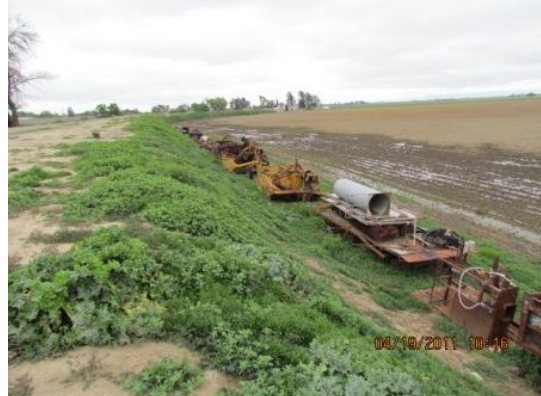
Photo 5 of 5 : FA_2015_RD0544_108_4_20150914_00006.jpg

Looking south at equipment along landside toe.

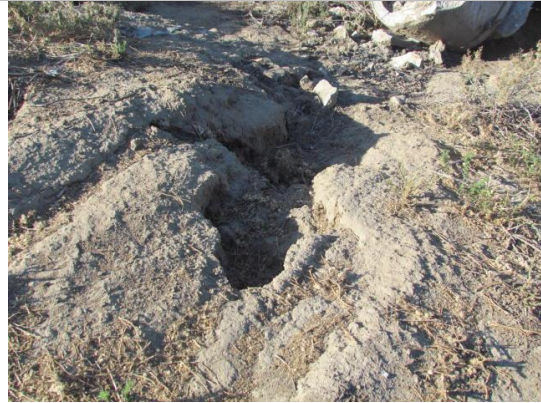
Photo 1 of 1 : FA_2015_RD0544_108_118_20151023_00093.jpg

LM Start	0.06	Rating **	U	Issue No.	118
LM End	0.06	Issue Type +	Ma	Location *	LS
Category	Earthen Levee			GPS Latitude/Longitude	
				Start	End
Item	Erosion / Bank Caving			37.869570 °	37.869570 °
				-121.329556 °	-121.329556 °
DWR ID	DWR_RD0544_01_f_2015_118				
Action/Comments					
Note and monitor erosion site.					
Inspector Comments: Finger erosion noted on landward slope.

Looking west at landside erosion for shoulder to middle of levee slope.

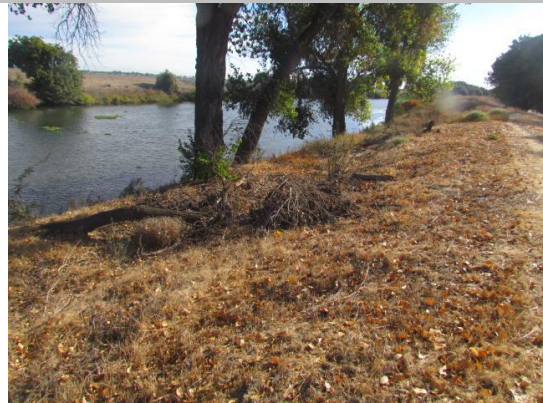
Photo 1 of 1 : FA_2015_RD0544_108_6_20150914_00008.jpg

LM Start	0.45	Rating **	M	Issue No.	6
LM End	0.45	Issue Type +	Ma	Location *	WS
Category	Earthen Levee			GPS Latitude/Longitude	
				Start	End
Item	Encroachments			37.864713 °	37.864713 °
				-121.326708 °	-121.326708 °
DWR ID	DWR_RD0544_01_f_2013_6				
Action/Comments					
Prunings					
Inspector Comments: Broken tree limbs on waterward slope and berm.

Looking southeast at tree branch on waterward slope.

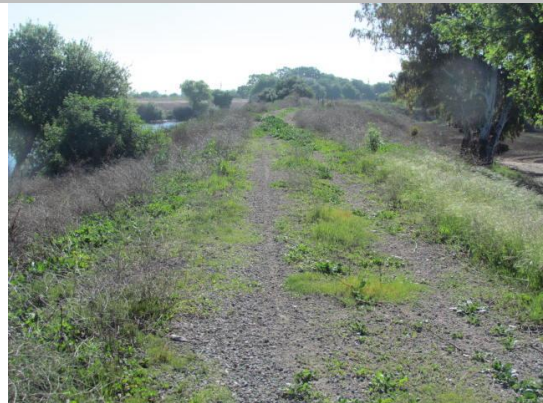
Photo 1 of 2 : FA_2015_RD0544_108_3_20150914_00002.jpg

LM Start	0.48	Rating **	A/W	Issue No.	3
LM End	0.67	Issue Type +	Ma	Location *	WS
Category	Earthen Levee			GPS Latitude/Longitude	
				Start	End
Item	Vegetation			37.864578 °	37.863753 °
				-121.326210 °	-121.322835 °
DWR ID	DWR_RD0544_01_s_2012_3				
Action/Comments					
Remove the wild growth other than native grasses from the levee slopes.					
Inspector Comments: Issue has been corrected, but should be monitored.

Looking south at typical view of levee. (Spring 2014)

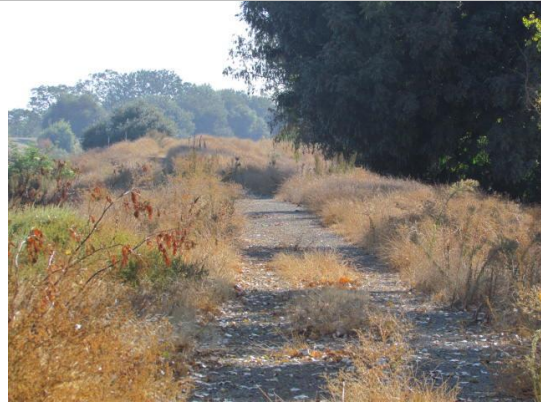
Photo 2 of 2 : FA_2015_RD0544_108_3_20150914_00003.jpg

Looking south at overgrown on landward and waterward slopes.

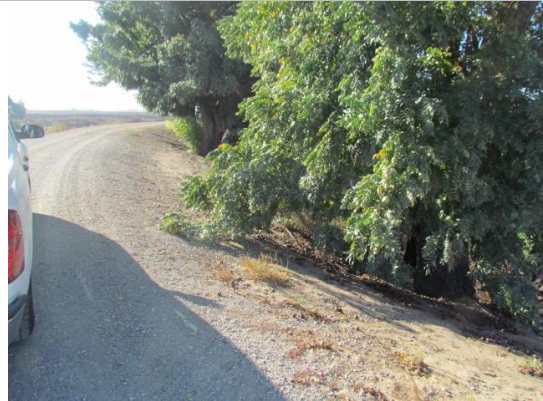
Photo 1 of 2 : FA_2015_RD0544_108_39_20151023_00097.jpg

Looking southwest at untrimmed tree at landward slope and toe fall

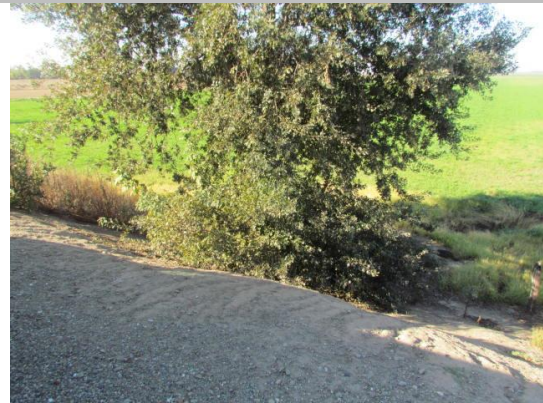
Photo 1 of 1 : FA_2015_RD0544_108_87_20151023_00098.jpg

Looking west at untrimmed tree at landward toe fall 2015.

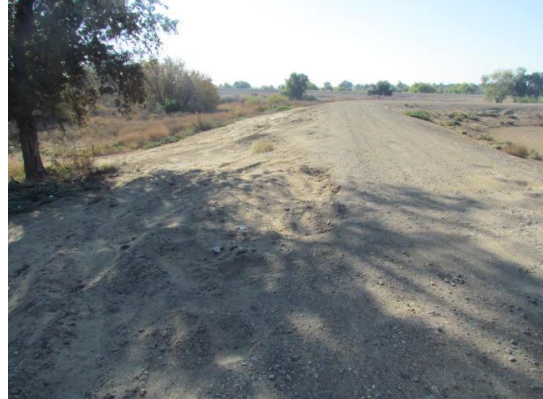
Photo 1 of 3 : FA_2015_RD0544_108_119_20151023_00099.jpg

LM Start	1.50	Rating **	U	Issue No.	119
LM End	1.51	Issue Type +	Ma	Location *	WS
Category	Earthen Levee			GPS Latitude/Longitude	
				Start	End
Item	Slope Stability			37.854844 °	37.854564 °
				-121.321090 °	-121.321031 °
DWR ID	DWR_RD0544_01_f_2015_119				
Action/Comments					
Repair the levee slope damaged by vehicle traffic and prevent access where possible. Inspector Comments: Damaged levee slope due to fishermen using slope as a ramp.

Looking southeast at damaged waterward slope fall 2015.

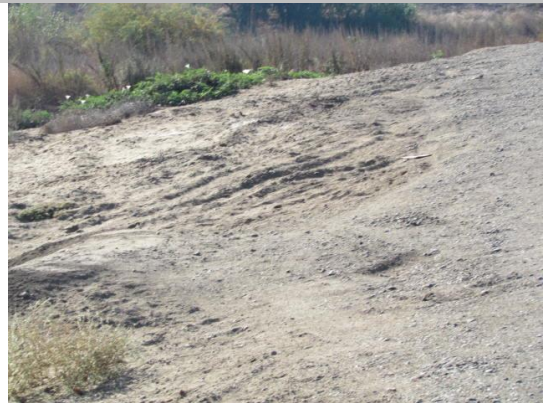
Photo 2 of 3 : FA_2015_RD0544_108_119_20151023_00100.jpg

Looking east at damaged waterward slope fall 2015.

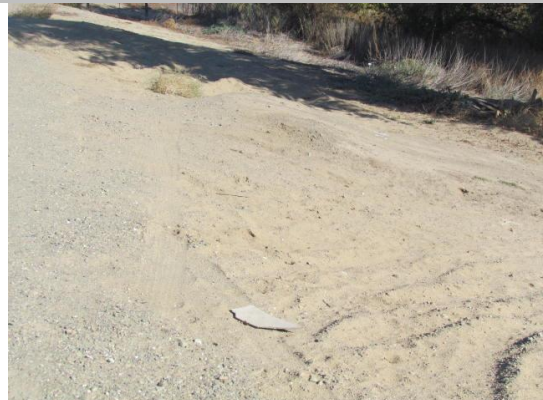
Photo 3 of 3 : FA_2015_RD0544_108_119_20151023_00101.jpg

Looking southeast at damaged waterward slope fall 2015

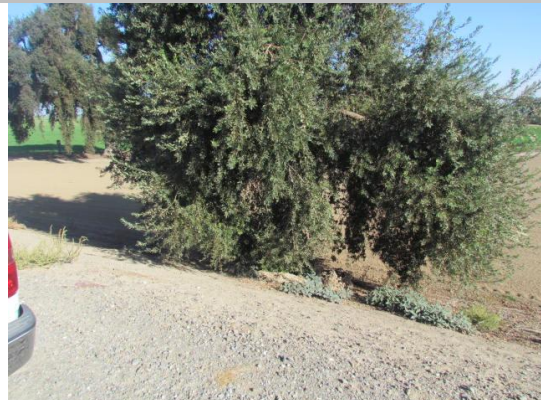
Photo 1 of 1 : FA_2015_RD0544_108_96_20151023_00102.jpg

Looking at untrimmed tree on landward slope and toe.

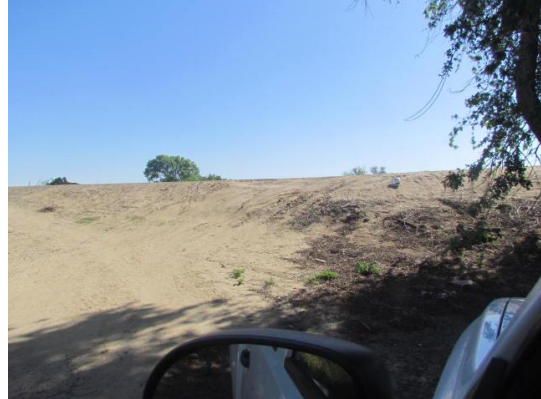
Photo 1 of 1 : FA_2015_RD0544_108_5_20150914_00007.jpg

LM Start	1.82	Rating **	M	Issue No.	5
LM End	1.82	Issue Type +	Ma	Location *	LS
Category	Earthen Levee			GPS Latitude/Longitude	
				Start	End
Item	Slope Stability			37.853188 °	37.853188
				-121.324145 °	-121.324145
DWR ID	DWR_RD0544_01_s _ 2013_5				
Action/Comments					
Repair the levee slope damaged by vehicle traffic and prevent access where possible.					
Inspector Comments: Slope damaged by vehicle traffic.

Looking east at landward slope damaged by vehicle traffic.

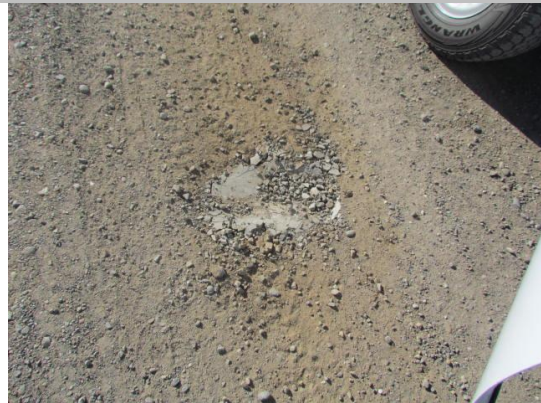
Photo 2 of 2 : FA_2015_RD0544_108_90_20150914_00064.jpg

Looking at grouted rodent hole on levee crown.

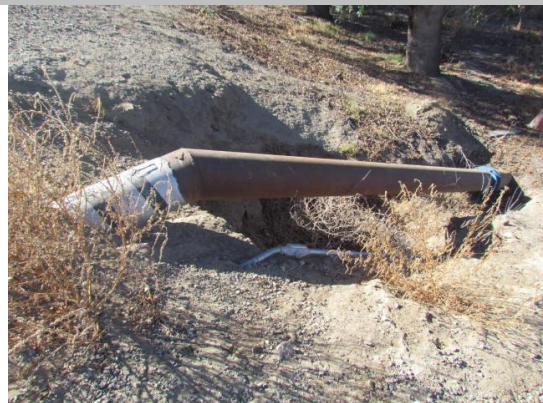
Photo 1 of 3 : FA_2015_RD0544_108_23_20150914_00027.jpg

LM Start	2.26	Rating **	U	Issue No.	23
LM End	2.26	Issue Type +	Ma	Location *	LS
Category	Earthen Levee			GPS Latitude/Longitude	
				Start	End
Item	Erosion / Bank Caving			37.848155 °	37.848155 °
				-121.324897 °	-121.324897 °
DWR ID	DWR_RD0544_01_s_2012_23				
Action/Comments					
Schedule repair of erosion site prior to the next inspection.					
Inspector Comments: Caving/erosion around irrigation pipe on landside slope.

Looking south at erosion around irrigation pipe on landside slope. (Fall 2014)

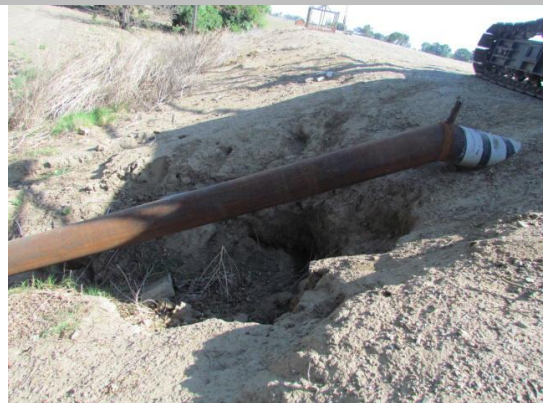
Photo 2 of 3 : FA_2015_RD0544_108_23_20150914_00028.jpg

Looking north at erosion under irrigation pipe on landside slope.

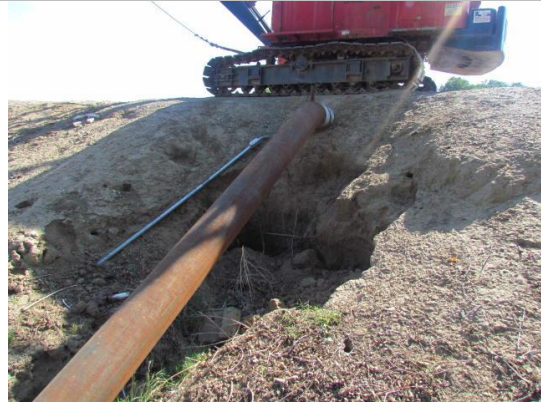
Photo 3 of 3 : FA_2015_RD0544_108_23_20150914_00029.jpg

LM Start	2.26	Rating **	U	Issue No.	23 (cont)
LM End	2.26	Issue Type +	Ma	Location *	LS
Category	Earthen Levee			GPS Latitude/Longitude	
				Start	End
Item	Erosion / Bank Caving			37.848155 °	37.848155 °
				-121.324897 °	-121.324897 °
DWR ID	DWR_RD0544_01_s_2012_23				
Action/Comments					
Schedule repair of erosion site prior to the next inspection. Inspector Comments: Caving/erosion around irrigation pipe on landside slope.

Looking east at erosion under irrigation pipe on landside slope.

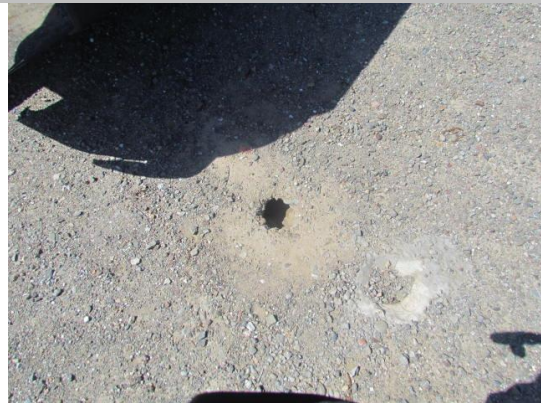
Photo 2 of 2 : FA_2015_RD0544_108_34_20150914_00039.jpg

Looking at rodent hole on levee crown.

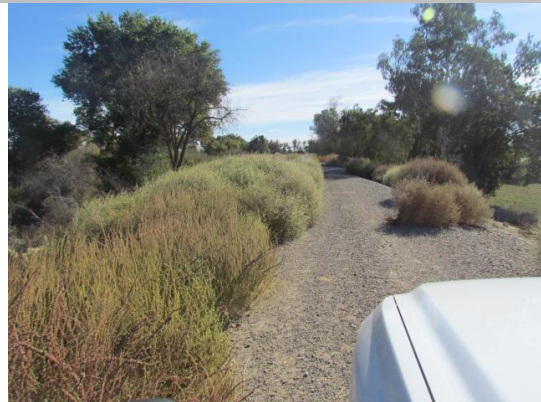
Photo 1 of 1 : FA_2015_RD0544_108_99_20150914_00068.jpg

Looking south at dense vegetation on waterward shoulder and slope.

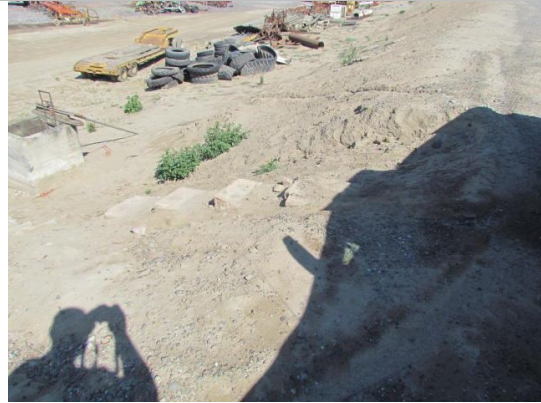
Photo 1 of 2 : FA_2015_RD0544_108_60_20150914_00049.jpg

LM Start	2.57	Rating **	M	Issue No.	60
LM End	2.57	Issue Type +	Ma	Location *	LS
Category	Earthen Levee			GPS Latitude/Longitude	
				Start	End
Item	Slope Stability			37.844337 °	37.844337 °
				-121.321853 °	-121.321853 °
DWR ID	DWR_RD0544_01_s _ 2012_60				
Action/Comments					
Repair the levee slope damaged by foot traffic and prevent access where possible.					
Inspector Comments: Finger erosion on landward slope.

Looking north at slope damage on landside slope.

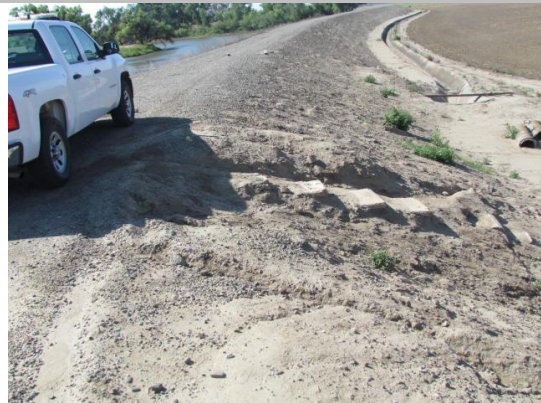
Photo 2 of 2 : FA_2015_RD0544_108_60_20150914_00050.jpg

Looking south at slope damage on landside slope.

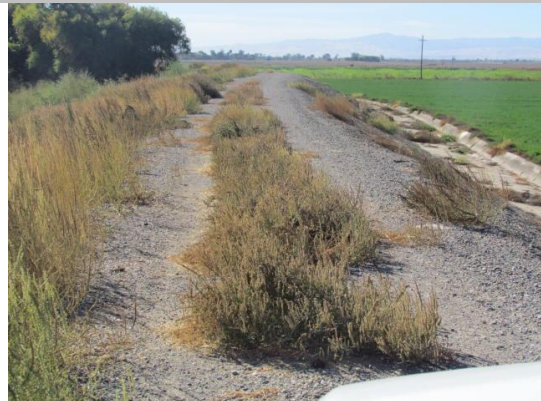
Photo 1 of 1 : FA_2015_RD0544_108_100_20150914_00069.jpg

Looking south at vegetation on levee crown.

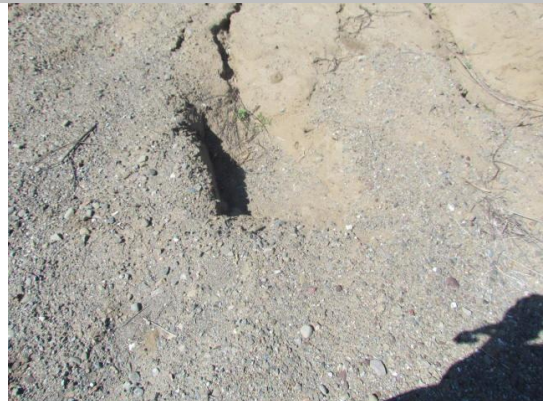
Photo 1 of 2 : FA_2015_RD0544_108_107_20150914_00072.jpg

Looking south at depression on landward slope.

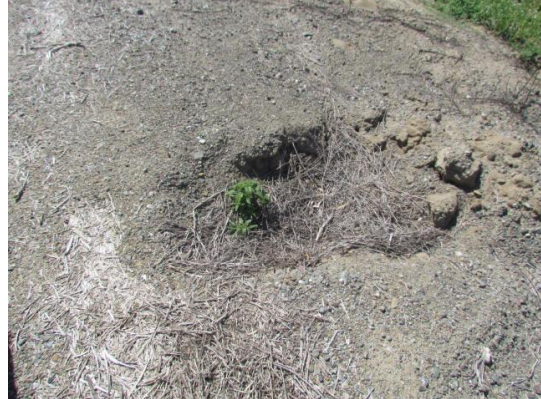
Photo 2 of 2 : FA_2015_RD0544_108_107_20150914_00073.jpg

Looking west at depression on landward shoulder.

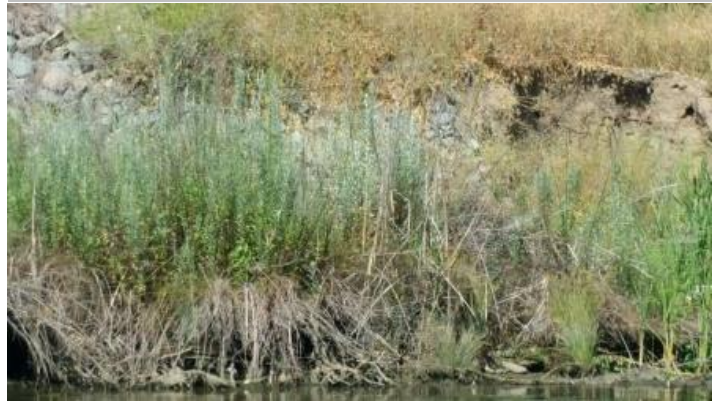
Photo 1 of 2 : SJR2015_RD0544U01RM49.67_2.jpg

LM Start	2.95	Rating **	U	Issue No.	38
LM End	2.95	Issue Type +	Ma	Location *	WS
Category	Supplemental			GPS Latitude/Longitude	
				Start	End
Item	DWR Erosion Survey			37.840697 °	37.840697 °
				-121.318252 °	-121.318252 °
DWR ID					
Action/Comments					
Inspector Comments: 06/24/2015: No significant change observed. 6/19/2014: No significant change observed. 08/13/2013: Pump has been removed. A larger pocket erosion has been found at the erosion site. 08/07/2012: The erosion is immediately upstream of a river bend. Dense vegetation is visible at the erosion site. [2015 Site ID:RD0544U01RM49.67]

Close view of the site.

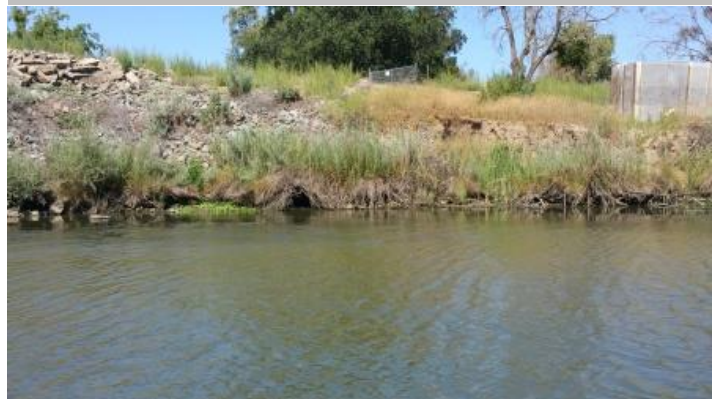
Photo 2 of 2 : SJR2015_RD0544U01RM49.67_3.jpg

Front view of the erosion.

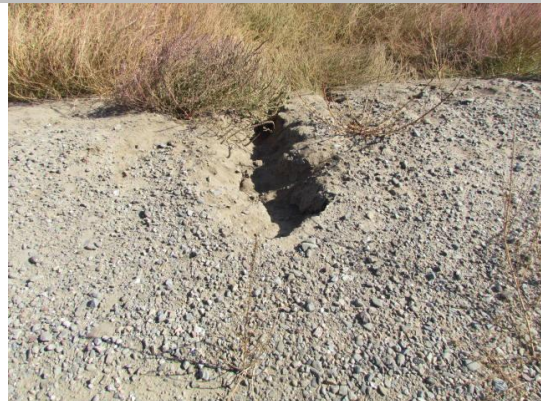
Photo 1 of 1 : FA_2015_RD0544_108_76_20150914_00057.jpg

LM Start	3.14	Rating **	M	Issue No.	76
LM End	3.14	Issue Type +	Ma	Location *	WS
Category	Earthen Levee			GPS Latitude/Longitude	
				Start	End
Item	Slope Stability			37.837929 °	37.837929 °
				-121.317663 °	-121.317663 °
DWR ID	DWR_RD0544_01_f_2013_76				
Action/Comments					
Repair slope instability. Inspector Comments: Slope damaged extends from levee slope to shoulder.

Looking east at slope damage on waterward slope.

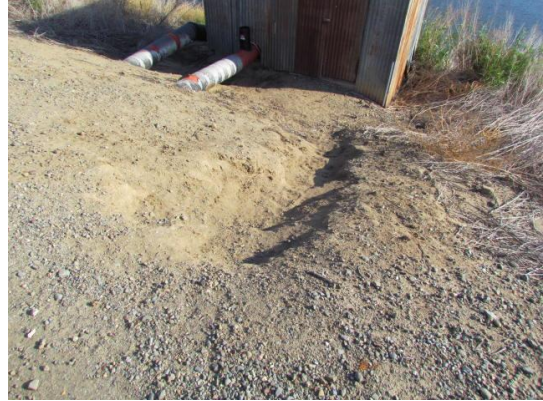
Photo 1 of 1 : FA_2015_RD0544_108_62_20150914_00051.jpg

LM Start	3.17	Rating **	M	Issue No.	62
LM End	3.17	Issue Type +	Ma	Location *	WS
Category	Earthen Levee			GPS Latitude/Longitude	
				Start	End
Item	Slope Stability			37.837530 °	37.837530
				-121.317510 °	-121.317510
DWR ID	DWR_RD0544_01_s _ 2012_62				
Action/Comments					
Repair the levee slope damaged by foot traffic and prevent access where possible.					
Inspector Comments: Slope damage due to foot traffic.

Looking east at slope damaged by foot traffic near pump house on waterside of levee.

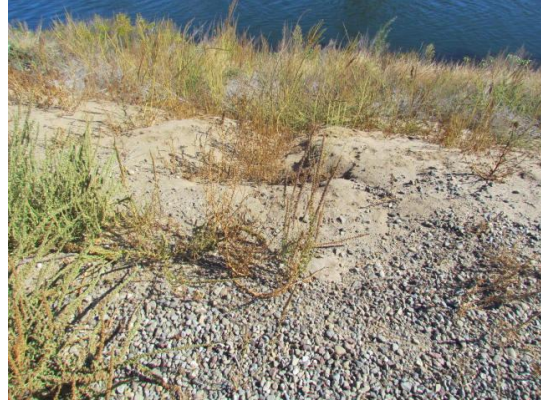
Photo 1 of 1 : FA_2015_RD0544_108_50_20150914_00046.jpg

Looking east at erosion on waterward slope.

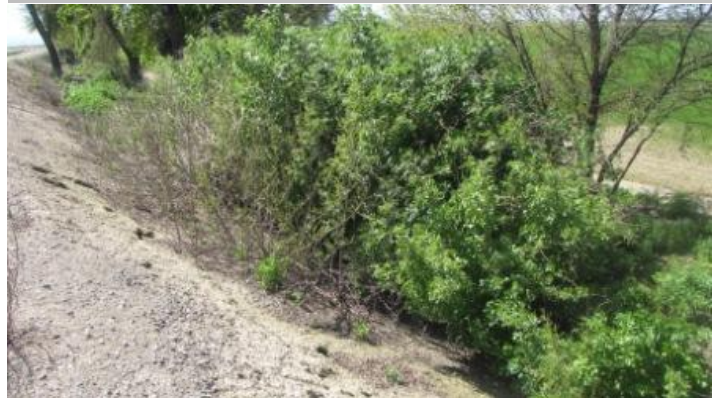
Photo 1 of 1 : FA_2015_RD0544_108_41_20150914_00043.jpg

Looking south at elderberries on landside slope and toe.

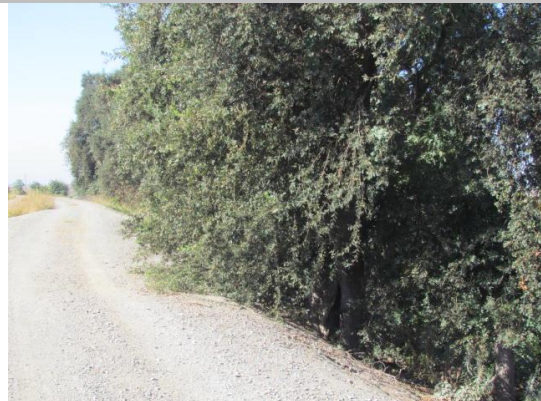
Photo 1 of 1 : FA_2015_RD0544_108_104_20151023_00116.jpg

Looking southwest at dense untrimmed trees on landward slope fall 2015.

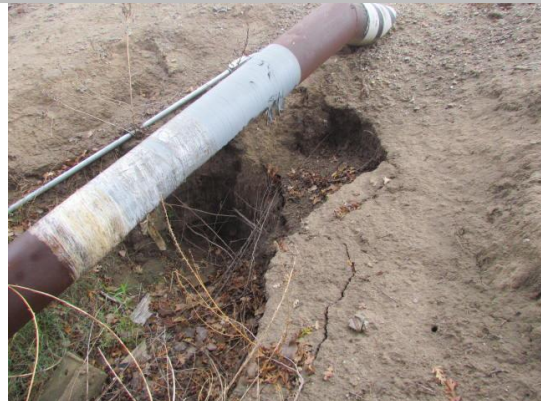
Photo 1 of 2 : FA_2015_RD0544_108_28_20150914_00031.jpg

Looking northeast at erosion around irrigation pipe on landside slope.

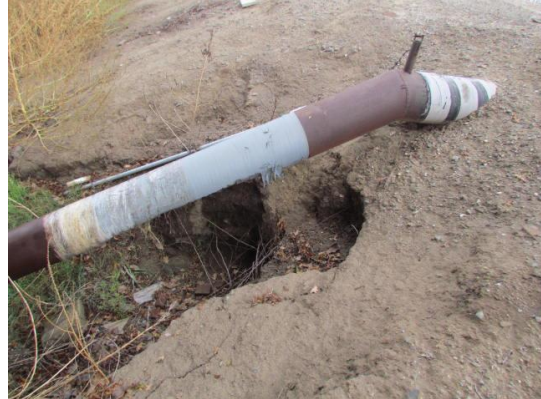
Photo 2 of 2 : FA_2015_RD0544_108_28_20150914_00032.jpg

Looking north at erosion around irrigation pipe on landside

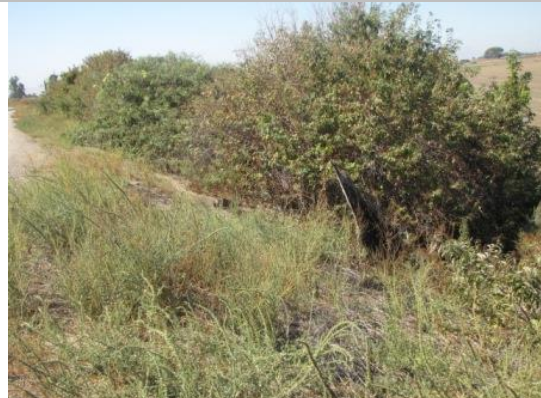
Photo 2 of 2 : FA_2015_RD0544_108_18_20150914_00025.jpg

Looking south at elderberries on landside slope and toe.

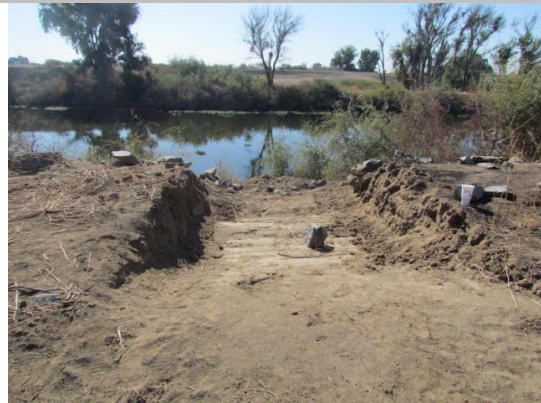
Photo 2 of 4 : FA_2015_RD0544_108_121_20151023_00110.jpg

Looking east at excavation on waterward berm.

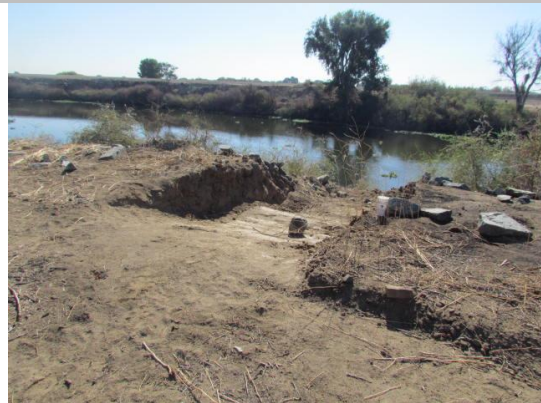
Photo 3 of 4 : FA_2015_RD0544_108_121_20151023_00111.jpg

Looking northeast at excavation on waterward berm

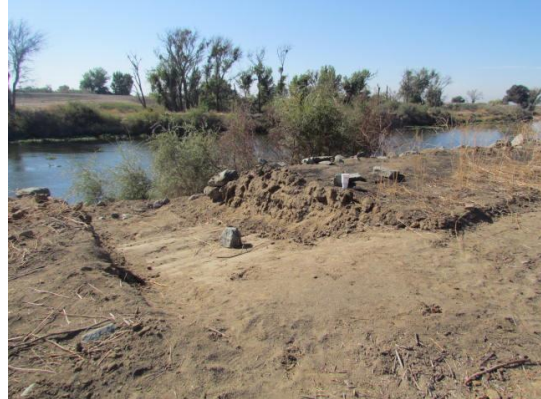
Photo 4 of 4 : FA_2015_RD0544_108_121_20151023_00112.jpg

Looking southeast at excavation on waterward berm.

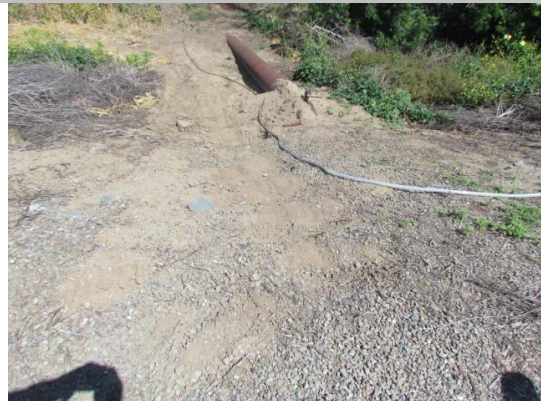
Photo 1 of 3 : FA_2015_RD0544_108_115_20150914_00076.jpg

Looking west at slope damage on landward slope.

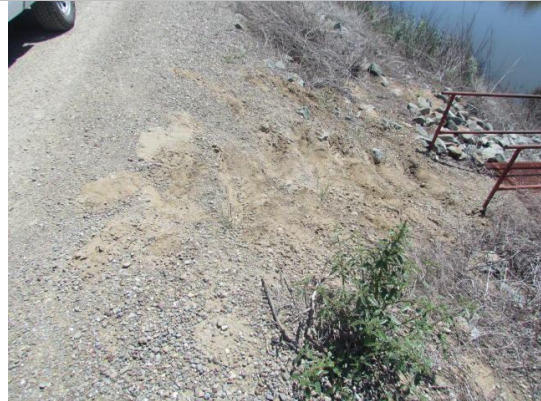
Photo 2 of 3 : FA_2015_RD0544_108_115_20150914_00077.jpg

Looking east at slope damage on waterward slope.

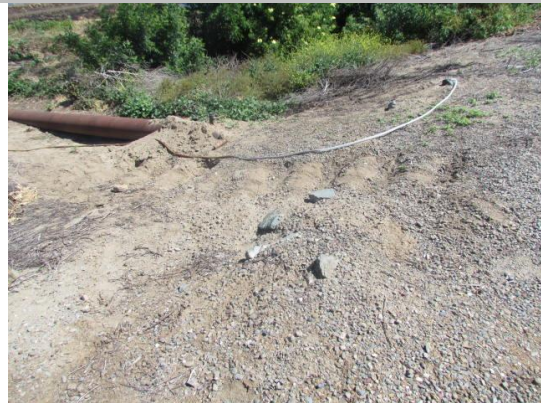
Photo 3 of 3 : FA_2015_RD0544_108_115_20150914_00078.jpg

Looking northwest at slope damage on landward toe.

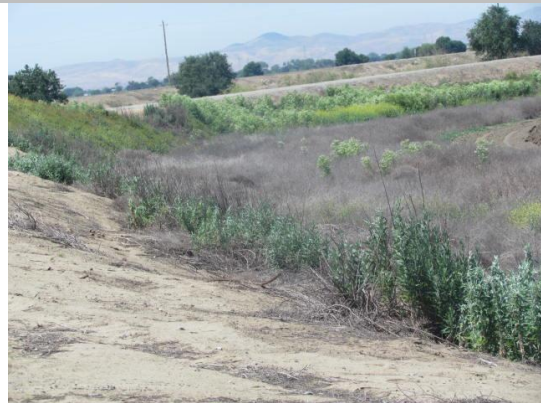
Photo 2 of 2 : FA_2015_RD0544_109_3_20150914_00002.jpg

Looking south at dense vegetation at landward toe spring 2014.

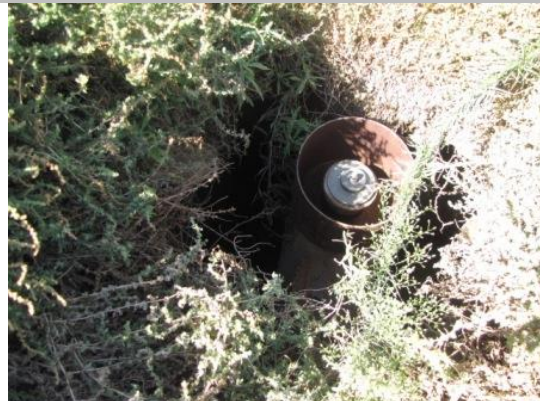
Photo 1 of 8 : FA_2015_RD0544_109_8_20150914_00008.jpg

Looking at top of siphon on waterside shoulder with 3' of caving around pipe.

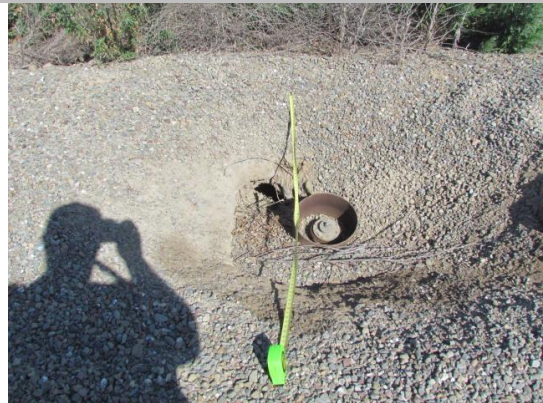
Photo 4 of 8 : FA_2015_RD0544_109_8_20150914_00011.jpg

Looking east at caving around siphon on waterside shoulder. (Spring 2012)

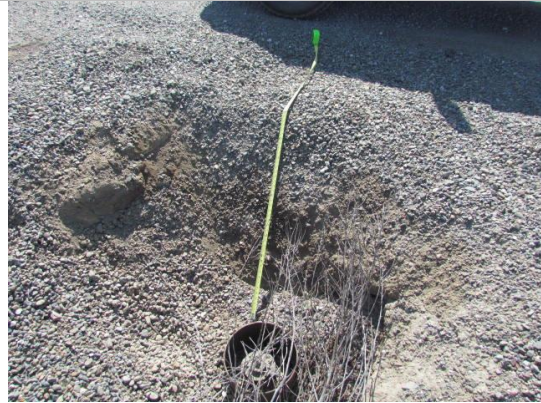
Photo 6 of 8 : FA_2015_RD0544_109_8_20150914_00013.jpg

Looking west at caving around siphon on waterside shoulder. (Spring 2012)

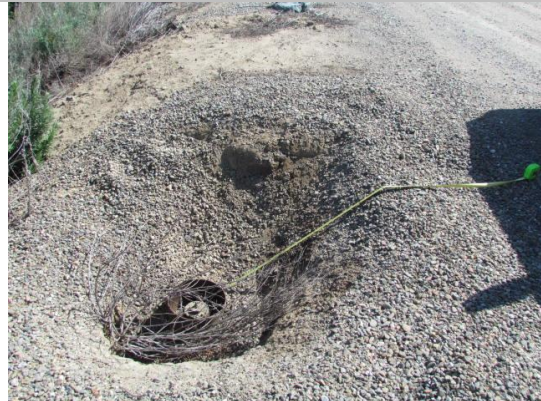
Photo 7 of 8 : FA_2015_RD0544_109_8_20150914_00014.jpg

Looking south at caving around siphon on waterside shoulder. (Spring 2012)

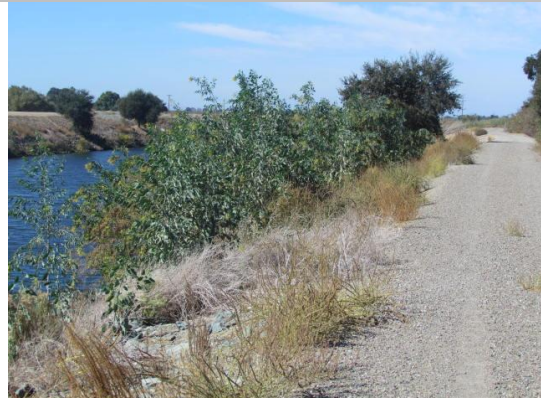
Photo 2 of 2 : FA_2015_RD0544_109_49_20150914_00046.jpg

Looking south at several tobacco plants on waterward slope.

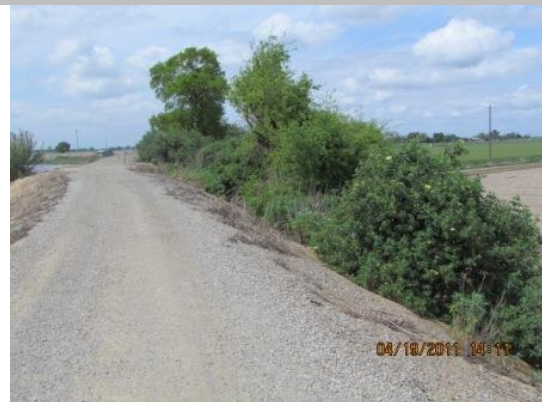
Photo 1 of 2 : FA_2015_RD0544_109_10_20150914_00017.jpg

Looking southwest at elderberries on landside slope.

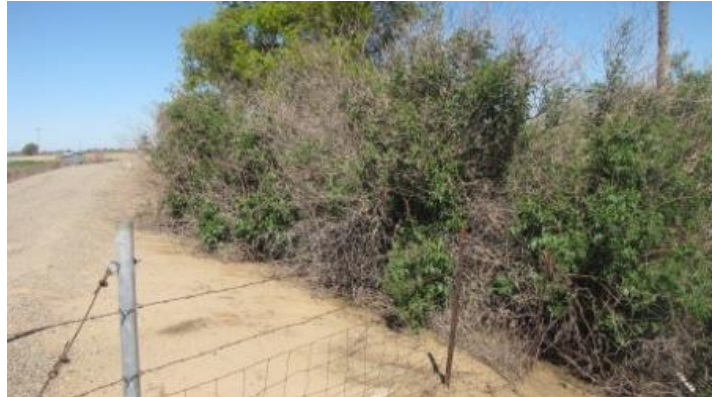
Photo 2 of 2 : FA_2015_RD0544_109_10_20150914_00018.jpg

Looking south at elderberries on landside slope and toe.

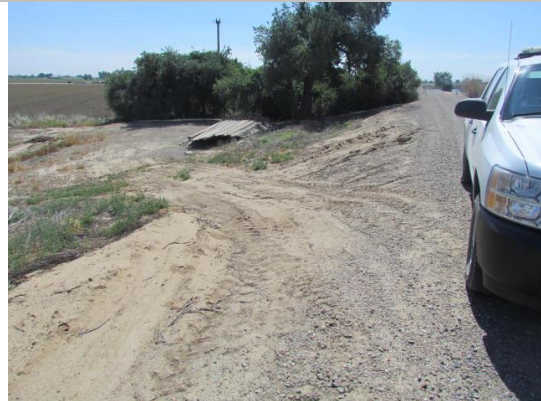
Photo 1 of 2 : FA_2015_RD0544_109_22_20150914_00033.jpg

Looking northwest at slope damage caused by vehicle traffic.

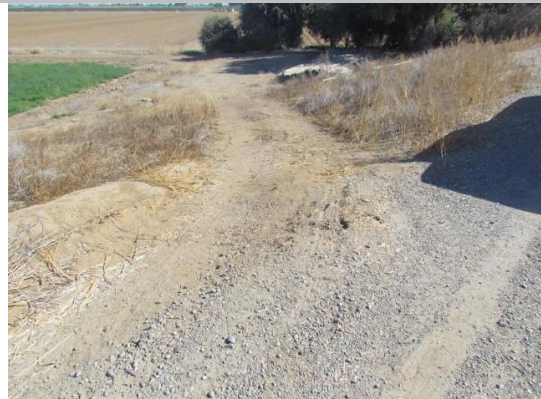
Photo 2 of 2 : FA_2015_RD0544_109_22_20150914_00034.jpg

Looking northwest at slope damage caused by vehicle traffic (Fall 2014).

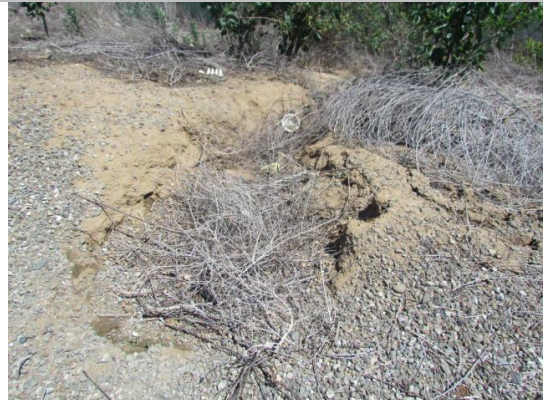
Photo 2 of 2 : FA_2015_RD0544_109_38_20150914_00042.jpg

Looking east at erosion/caving on waterward slope.

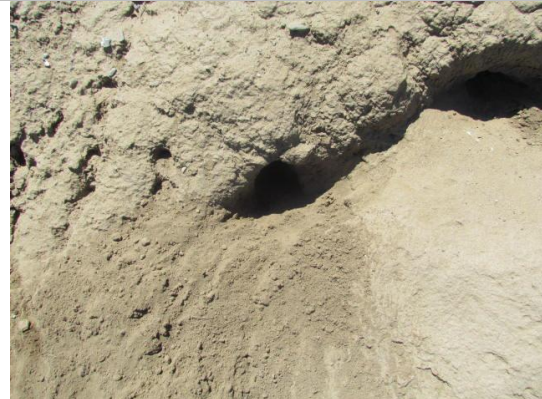
Photo 1 of 1 : FA_2015_RD0544_109_58_20150914_00051.jpg

Looking at typical rodent holes on landward slope.

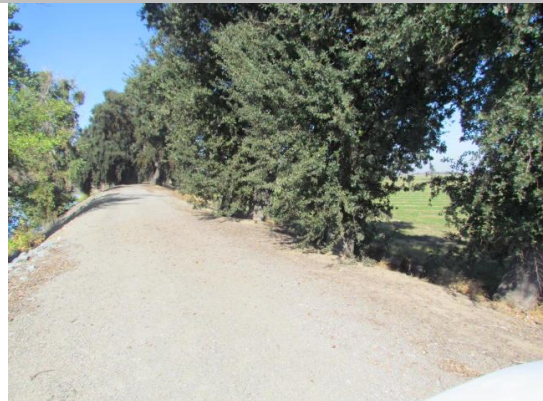
Photo 1 of 1 : FA_2015_RD0544_109_59_20151026_00065.jpg

Looking southwest at untrimmed trees on landward slope and toe fall 2015.

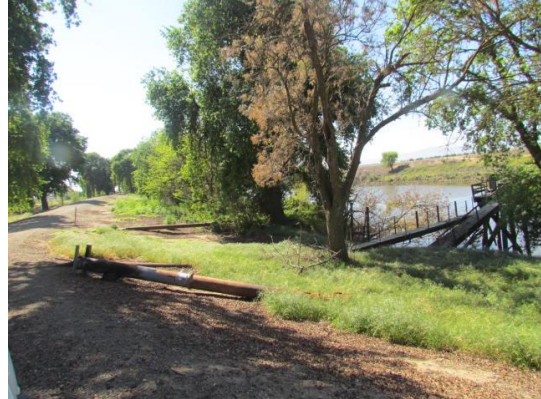
Photo 1 of 1 : FA_2015_RD0544_109_51_20150914_00048.jpg

Looking north at old pump shaft and pipe on waterward slope.

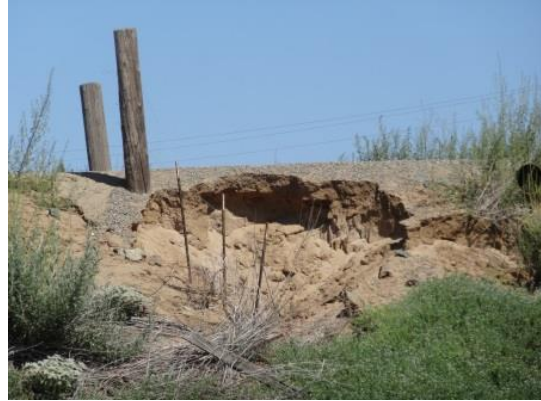
Photo 2 of 3 : SJR2015_RD0544U02RM33.00_6.JPG

Close view of the erosion.

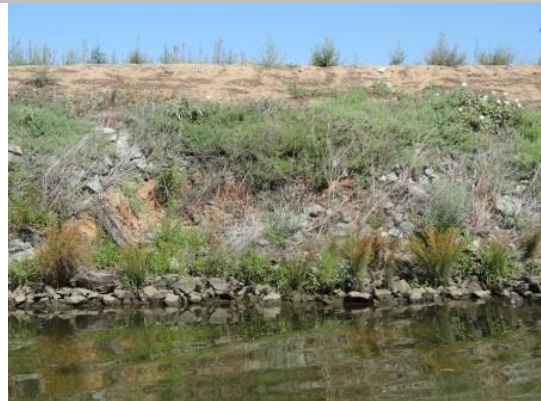
Photo 1 of 2 : SJR2015_RD0544U02RM32.91_2.jpg

Front view of pocket erosion. Note the vegetation and riprap at the site.

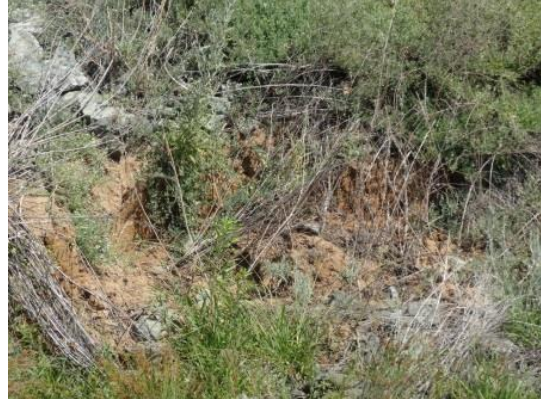
Photo 2 of 2 : SJR2015_RD0544U02RM32.91_4.jpg

Close view of pocket erosion.

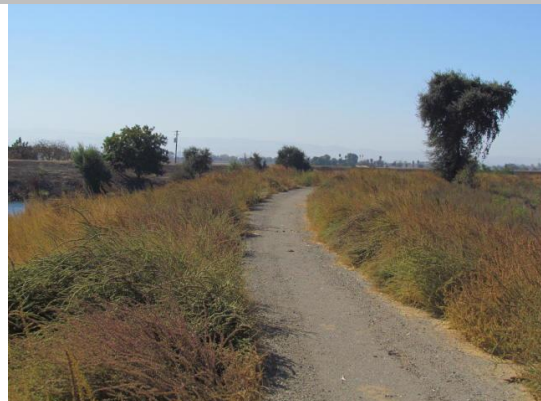
Photo 1 of 1 : FA_2015_RD0544_109_43_20150914_00043.jpg

Looking south a dense vegetation on landward and waterward slope.

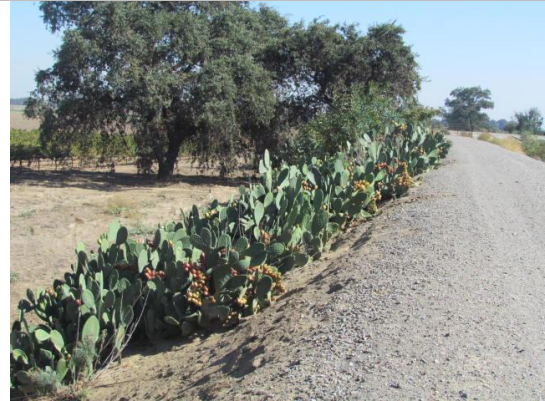
Photo 1 of 3 : FA_2015_RD0544_109_36_20151026_00074.jpg

Looking northwest at cactus on landward slope and toe fall 2015

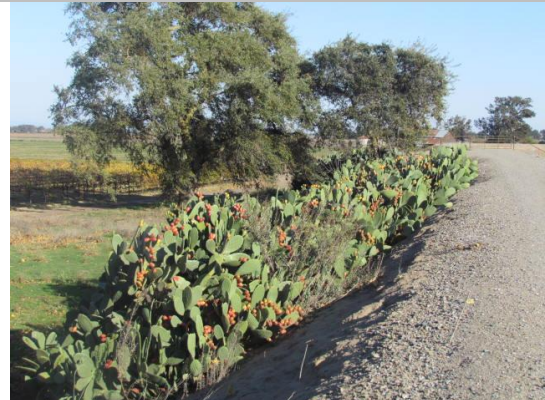
Photo 2 of 3 : FA_2015_RD0544_109_36_20150914_00039.jpg

Looking north at cactus on landside slope and toe spring 2015

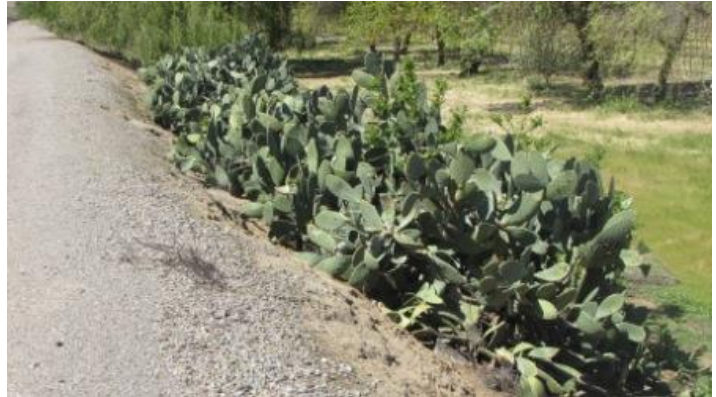
Photo 3 of 3 : FA_2015_RD0544_109_36_20150914_00040.jpg

Looking southwest at overgrown cactus on landside slope spring 2015.

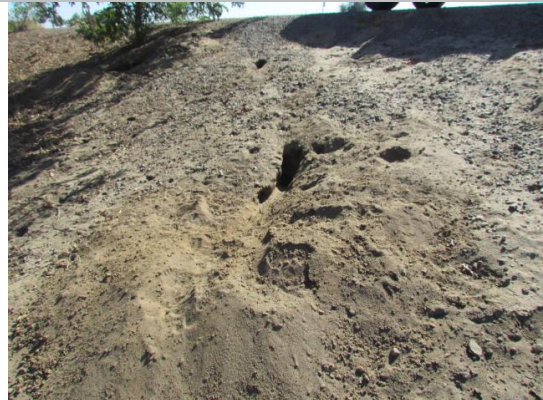
Photo 2 of 2 : FA_2015_RD0544_109_67_20151026_00077.jpg

Looking north at typical view of rodent holes on landward slope.

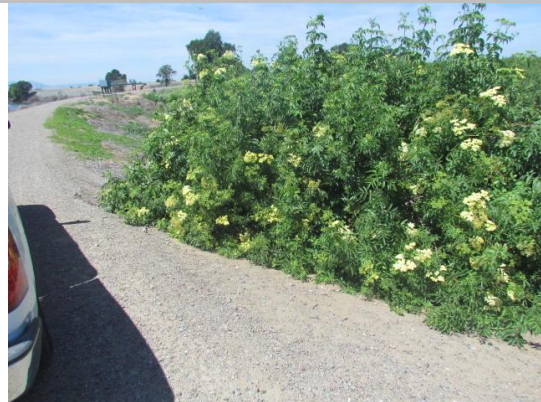
Photo 1 of 1 : FA_2015_RD0544_109_64_20150914_00052.jpg

Looking southwest at dense elderberry bush on landward slope and toe.
(Spring 2015)

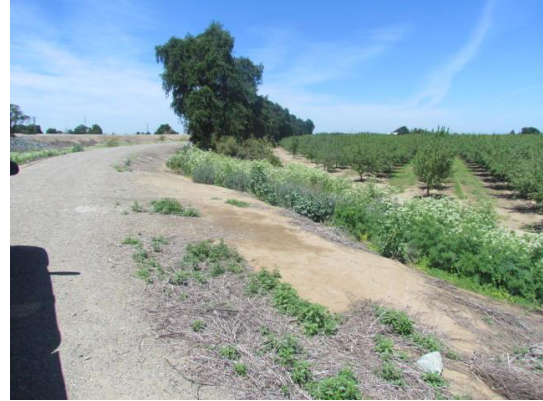
Photo 1 of 1 : FA_2015_RD0544_109_65_20150914_00053.jpg

Looking southwest at dense vegetation on landward slope and toe.
(Spring 2015)
